## **Reflective Cracking Testing Notes**

**Date:** March 07, 2017

**Project:** Reflective Cracking Indoor Phase 5

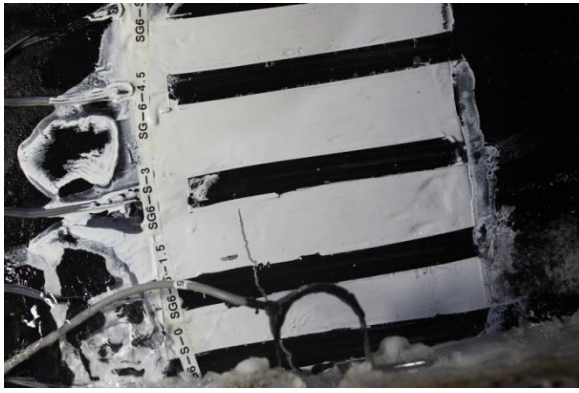
- Outer vertical edge:
  - Crack through SG6-S-0 and SG6-S-1.5. Crack stopped at SG6-S-3 as shown Figures 1 and 2.
  - Removed ice over SG6-S-0 and SG6-S-1.5.
  - SG6-S-1.5 gauge is open. SG6-S-0 was open before formal test began.
- Joint surface area:
  - Start from the South outer edge and work toward the inner edge. None of the surface gauges show evidence of a crack as shown in Figures 2, 3, 4 and 5.
- Inner vertical edge:
  - There is no evidence of a crack on the inner vertical edge as shown in Figure 6.

Figure 1. Crack through SG6-S-0 and SG6-S-1-5. No crack on SG6-S-3, SG6-S-4.5

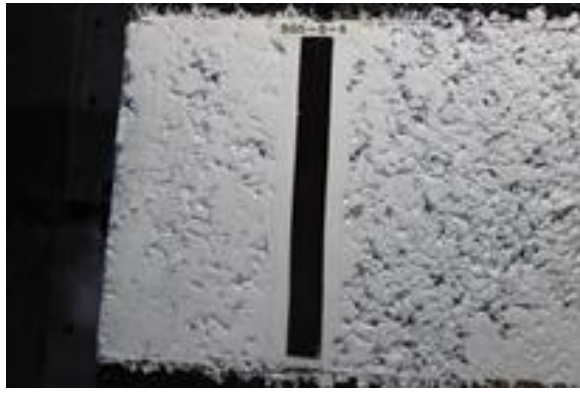
Figure 2. SG5-S-6, no crack

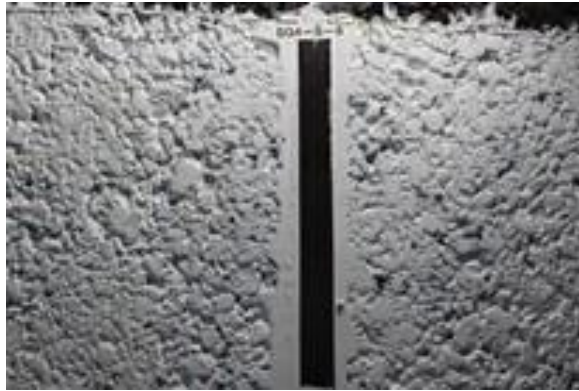
Figure 3. SG4-S-6, no crack.

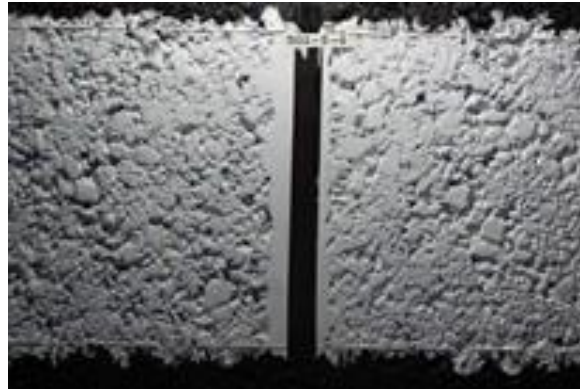
Figure 4. SG3-S-6, no crack.

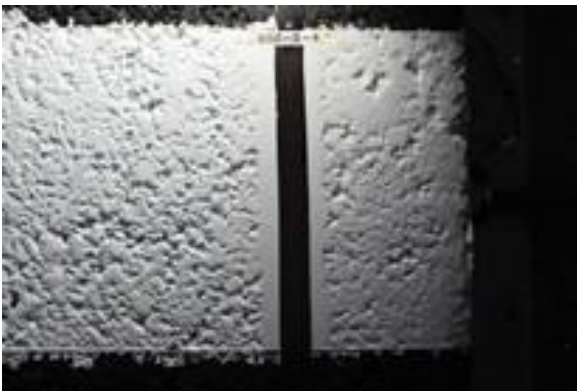
Figure 5. SG2-S-6, no crack.

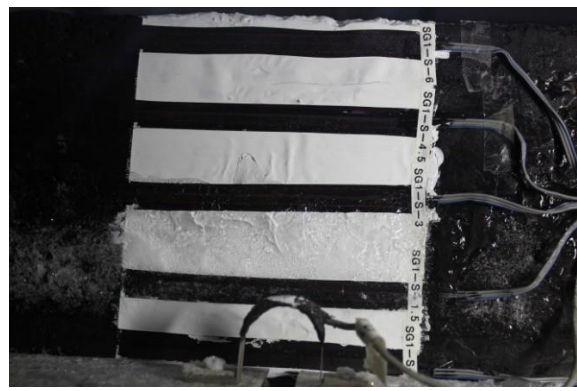
Figure 6. SG1-S-0 through SG1-S-6, no crack

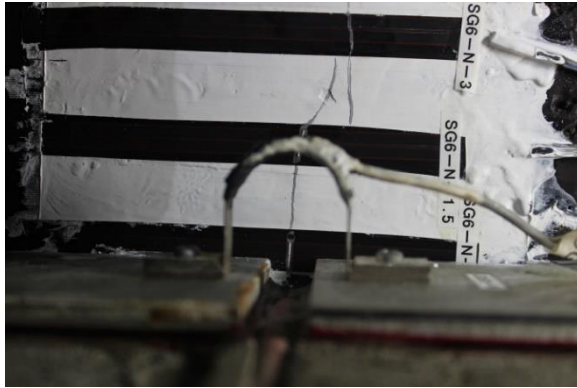
- Outer vertical edge:
  - Crack is more visible through the outer vertical edge. SG6-N-0, SG6-N-1.5 and SG6-N-3 as shown in Figure 7.
  - SG6-N-0, SG6-N-1.5 and SG6-N-3 gauges are open.
- Joint surface area:
  - Start from the north outer edge and work toward the inner edge, crack propagation through SG5-N-3, SG4-N-3 and SG3-N-3 as shown in Figures 8, 9 and 10.
  - SG5-N-3, SG4-N-3 and SG3-N-3 gauges are open.
  - Three-fifths of the north test section appears to be cracked as shown in Figure 13.
  - No crack on SG2-N-3 as shown in Figure 11.
- Inner vertical edge:
  - No crack on the inner vertical edge as shown in Figure 12.

Figure 7. SG6-N-0, SG6-N-1.5 and SG6-N-3. Bottom up crack completed up to the surface

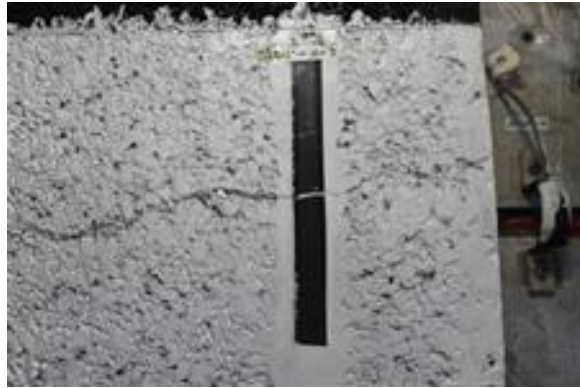
Figure 8. Crack propagation from the vertical edge through SG5-N-3

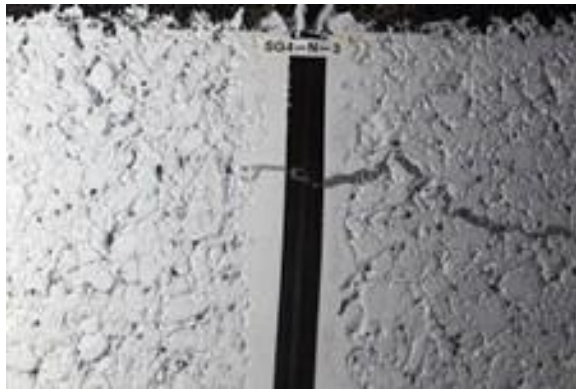
Figure 9. Crack from SG5-N-3 propagated through SG4-N-3

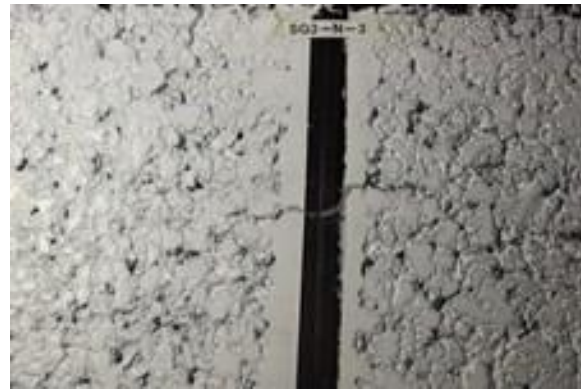
Figure 10. Crack from SG4-N-3 propagated SG3-N-3 and stopped

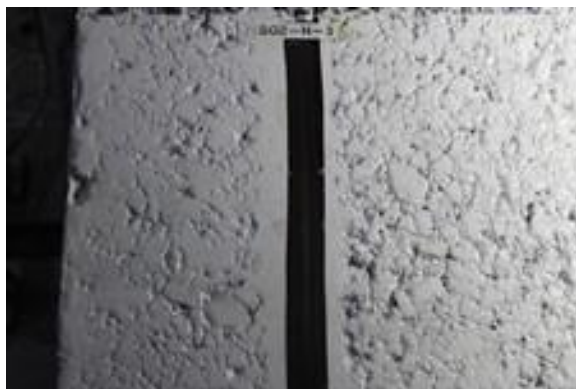
Figure 11. SG2-N-3, no crack.

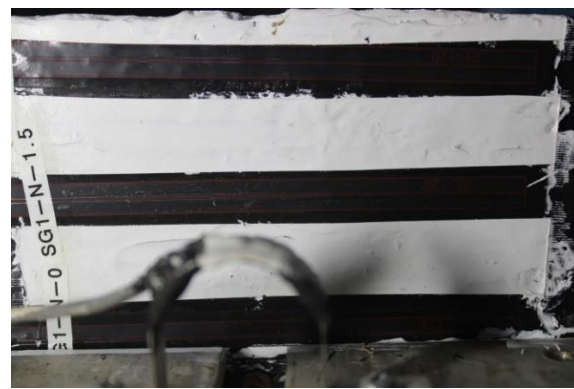
Figure 12. SG1-N-0, SG1-N-1.5 and SG1-N-3, no crack.

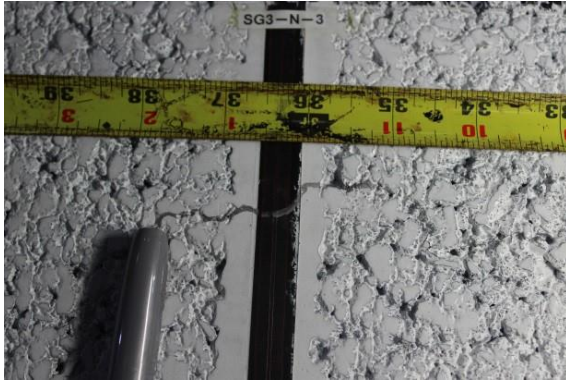
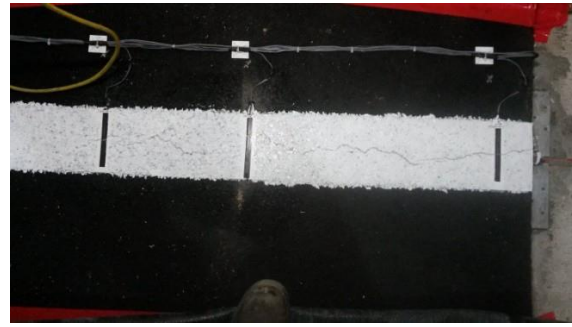
Figure 13. Three-fifths of the north test section appears to be crack (approximately 37.5")
